Loose Torque Rod Locknuts Cause Deadlines

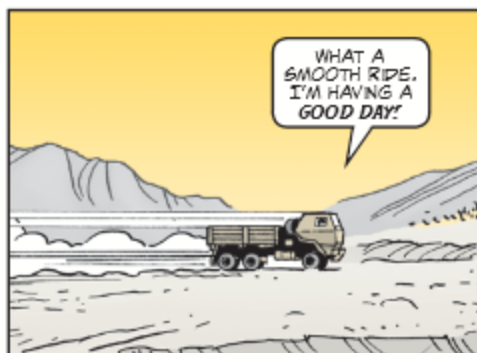
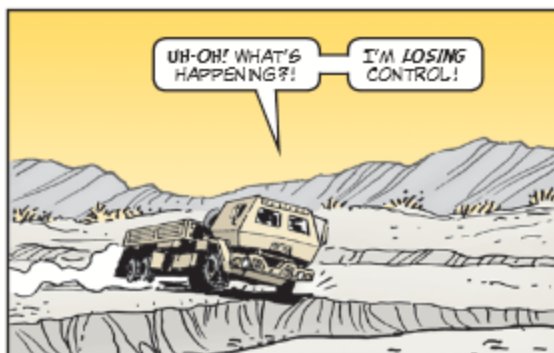
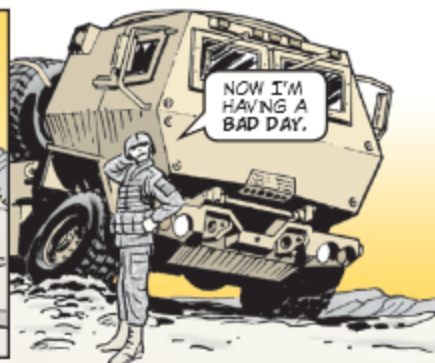
If you haven't already heard, a production error caused some FMTVA1P2 LTAS 6X6 (3-axle variant) trucks within the serial number range of 720,001-744,192 and M1095 trailers within the serial number range of 720,038-759,324 to roll off the line with improperly tightened torque rod nylon insert locknuts, NSN 5310-01-434-0078. The vehicles have four individual torque rods secured by eight nylon insert locknuts. If these locknuts are not installed and torqued properly, the individual torque rod could separate from the truck or trailer, putting you at risk for a loss of control, rollover, and collision.

Immediately inspect your FMTV LTAS 6X6 truck and M1095 trailer to see if each torque rod nylon insert locknut has threads that are visible beyond the locknut. A properly tightened nylon insert locknut will show 1-3 threads exposed past the nylon lock feature.

You won't see extending threads if the locknut is improperly torqued. That means your truck or trailer is non-mission capable (NMC) until all the nylon insert locknuts have been properly torqued.

By now, the corrective measures provided in TACOM SOUM 12-015 and TACOM SOUM 13-005 should be completed. But if they haven't been, or if you encounter loose torque rod locknuts, here's what you should do.

For your FMTVA1P2 LTAS truck, use the maintenance instructions found in the Rear Torque Rod Replacement work package of TM 9-2320-333-14&P (EM 0294, Jun 12). And for your M1095 trailer, refer to the maintenance guidance in WP 0097 of TM 9-2330-394-13&P.
